PHASE I ENVIRONMENTAL ASSESSMENT

Hancock Village - Phase 4
224 Independence Drive
Chestnut Hill, Middlesex County, Massachusetts 02467

Property Solutions Project No. 20074273

Date: JAN 07 2008

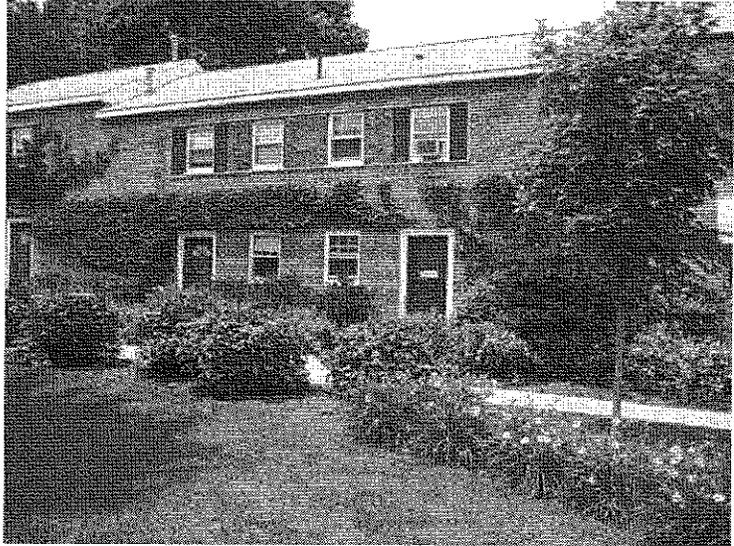
PHOTO 1.

Typical exterior of subject buildings

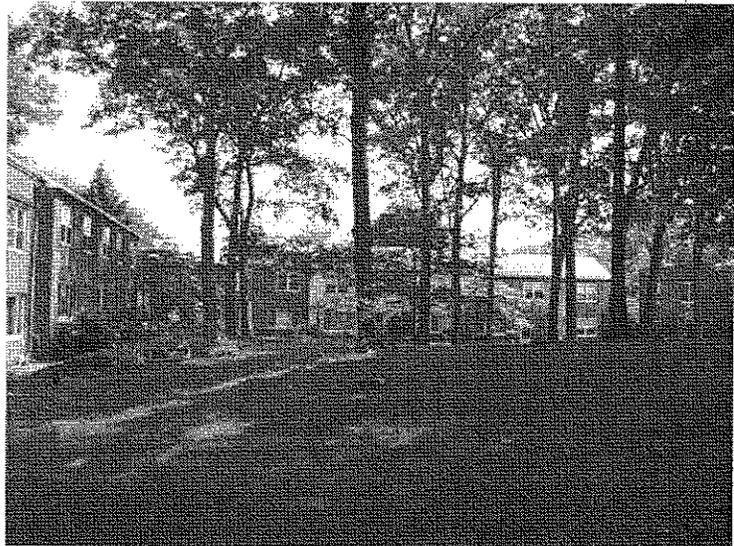
PHOTO 2.

Typical landscaped areas

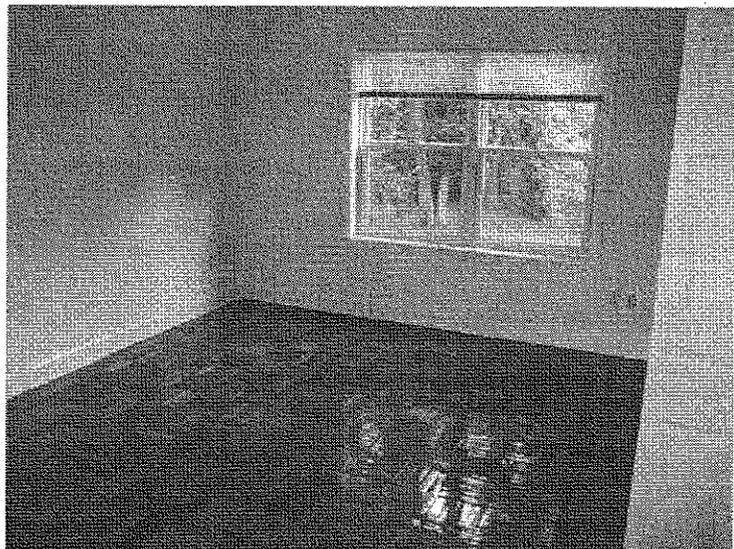
PHOTO 3.

Typical bedroom

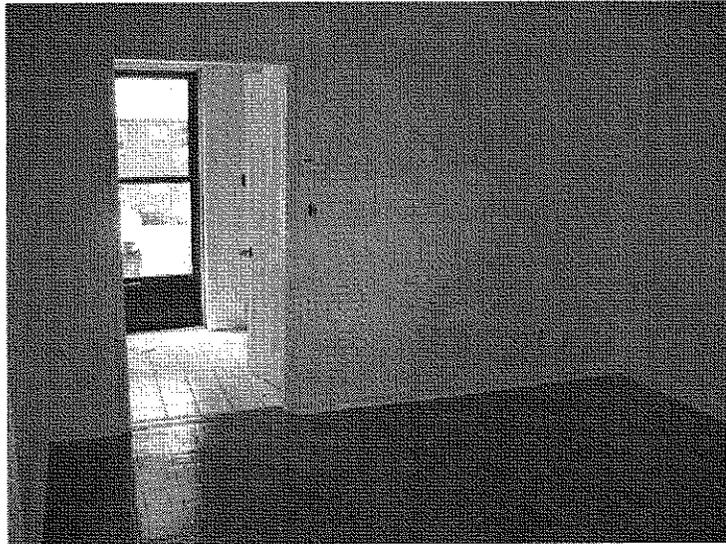
PHOTO 4.

Typical living room and entrance

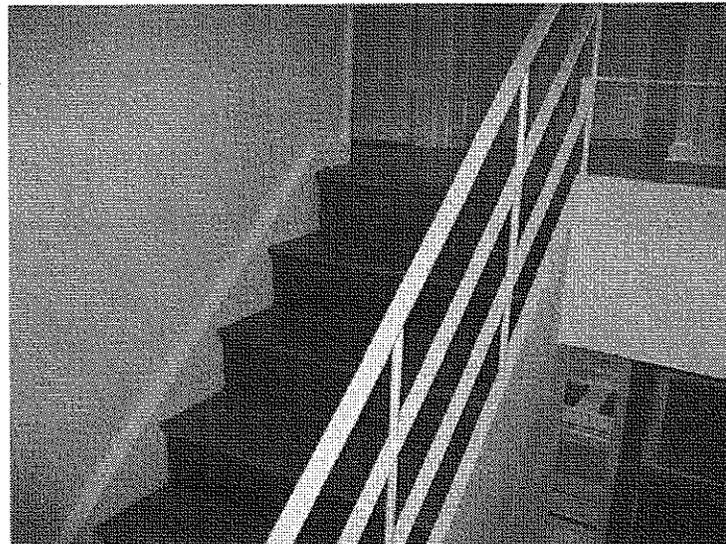
PHOTO 5.

Typical staircase

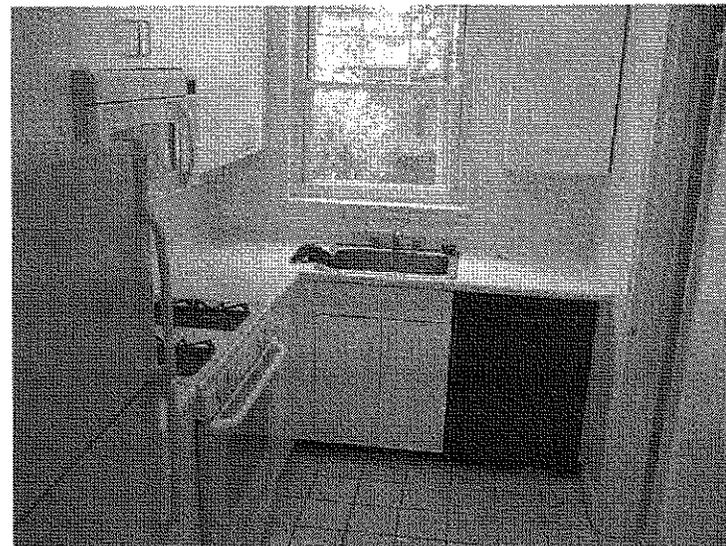
PHOTO 6.

Typical kitchen that has not be remodeled

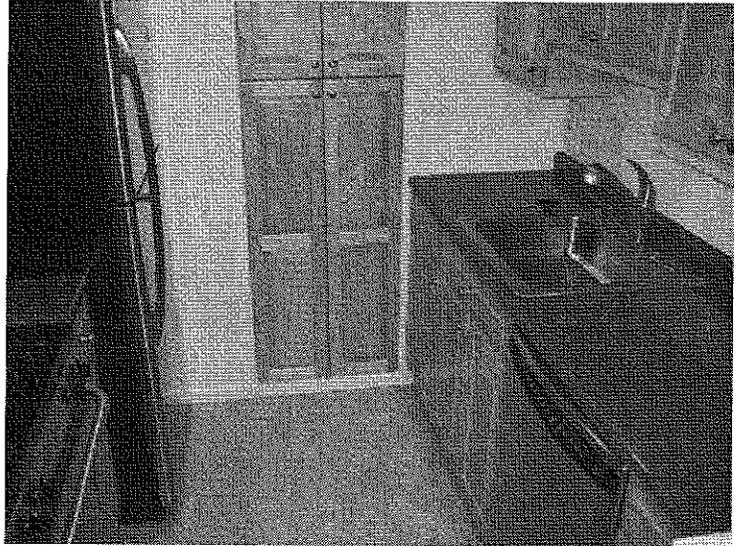
PHOTO 7.

Typical remodeled kitchen

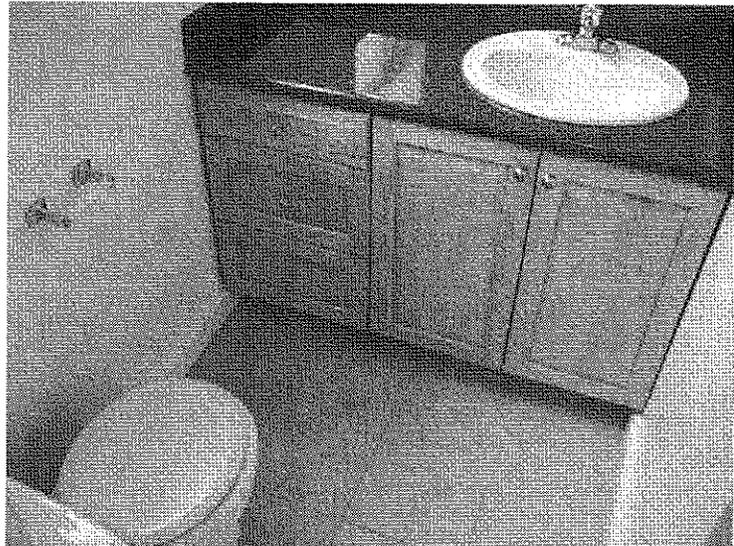
PHOTO 8.

Typical bathroom

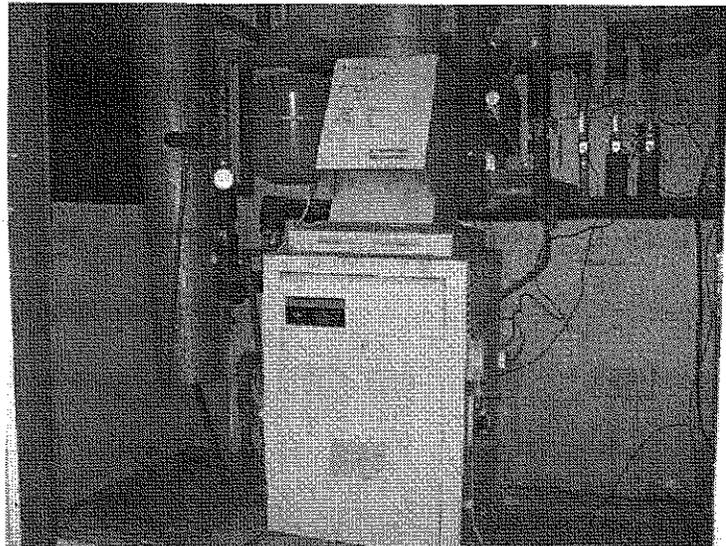
PHOTO 9.

Typical mechanical closet

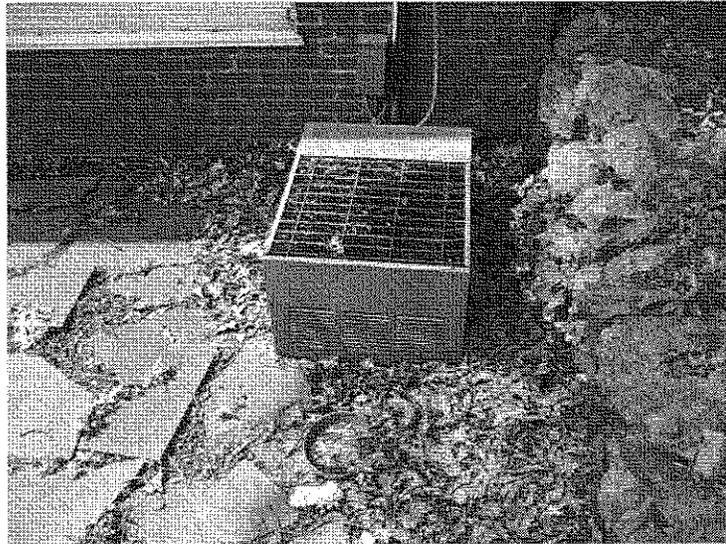
PHOTO 10.

Typical air conditioner

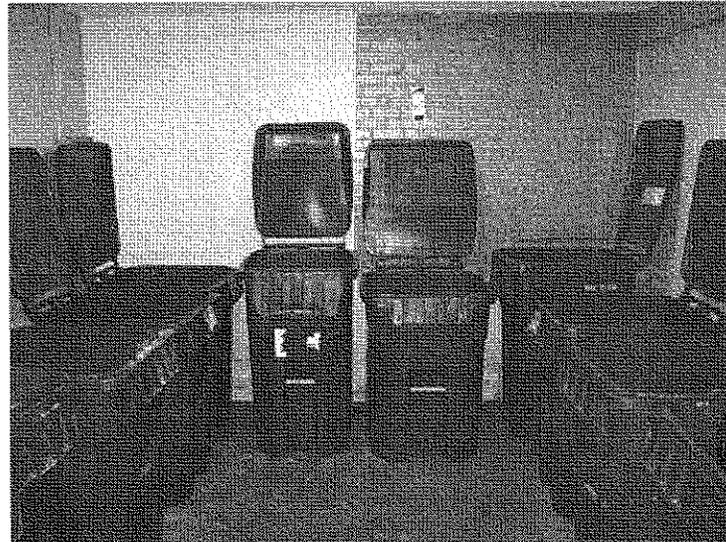
PHOTO 11.

Typical waste storage room

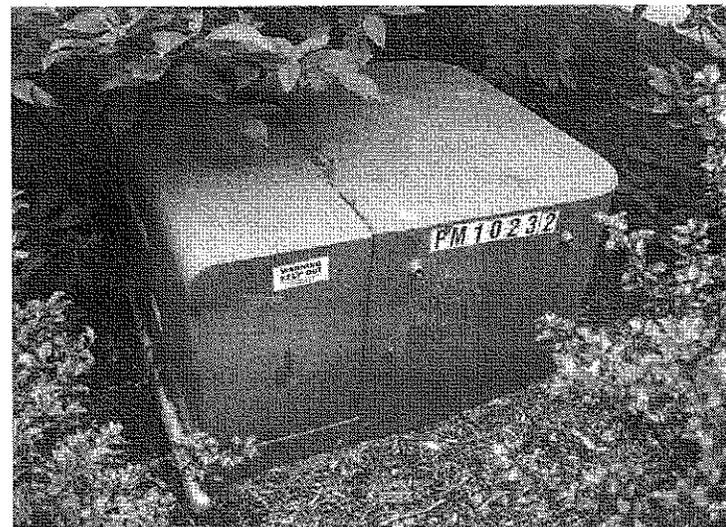
PHOTO 12.

During the property visit, Property Solutions observed a total of six pad-mounted transformers located on the subject property. There were no PCB labels or utility company markings on any of the transformers. No staining or leaks were observed in the vicinity of the transformers. All

Since the transformers are owned by NSTAR, and no spills or leaks were observed in the area of the transformers, these transformers are not expected to be an environmental concern at the subject property.

Typical pad mounted transformer
