TOWN OF BROOKLINE

Right Turn On Red Restriction

Chestnut Hill Avenue at Dean Street

Date: April 26, 2011
Prepared by: Daniel Martin

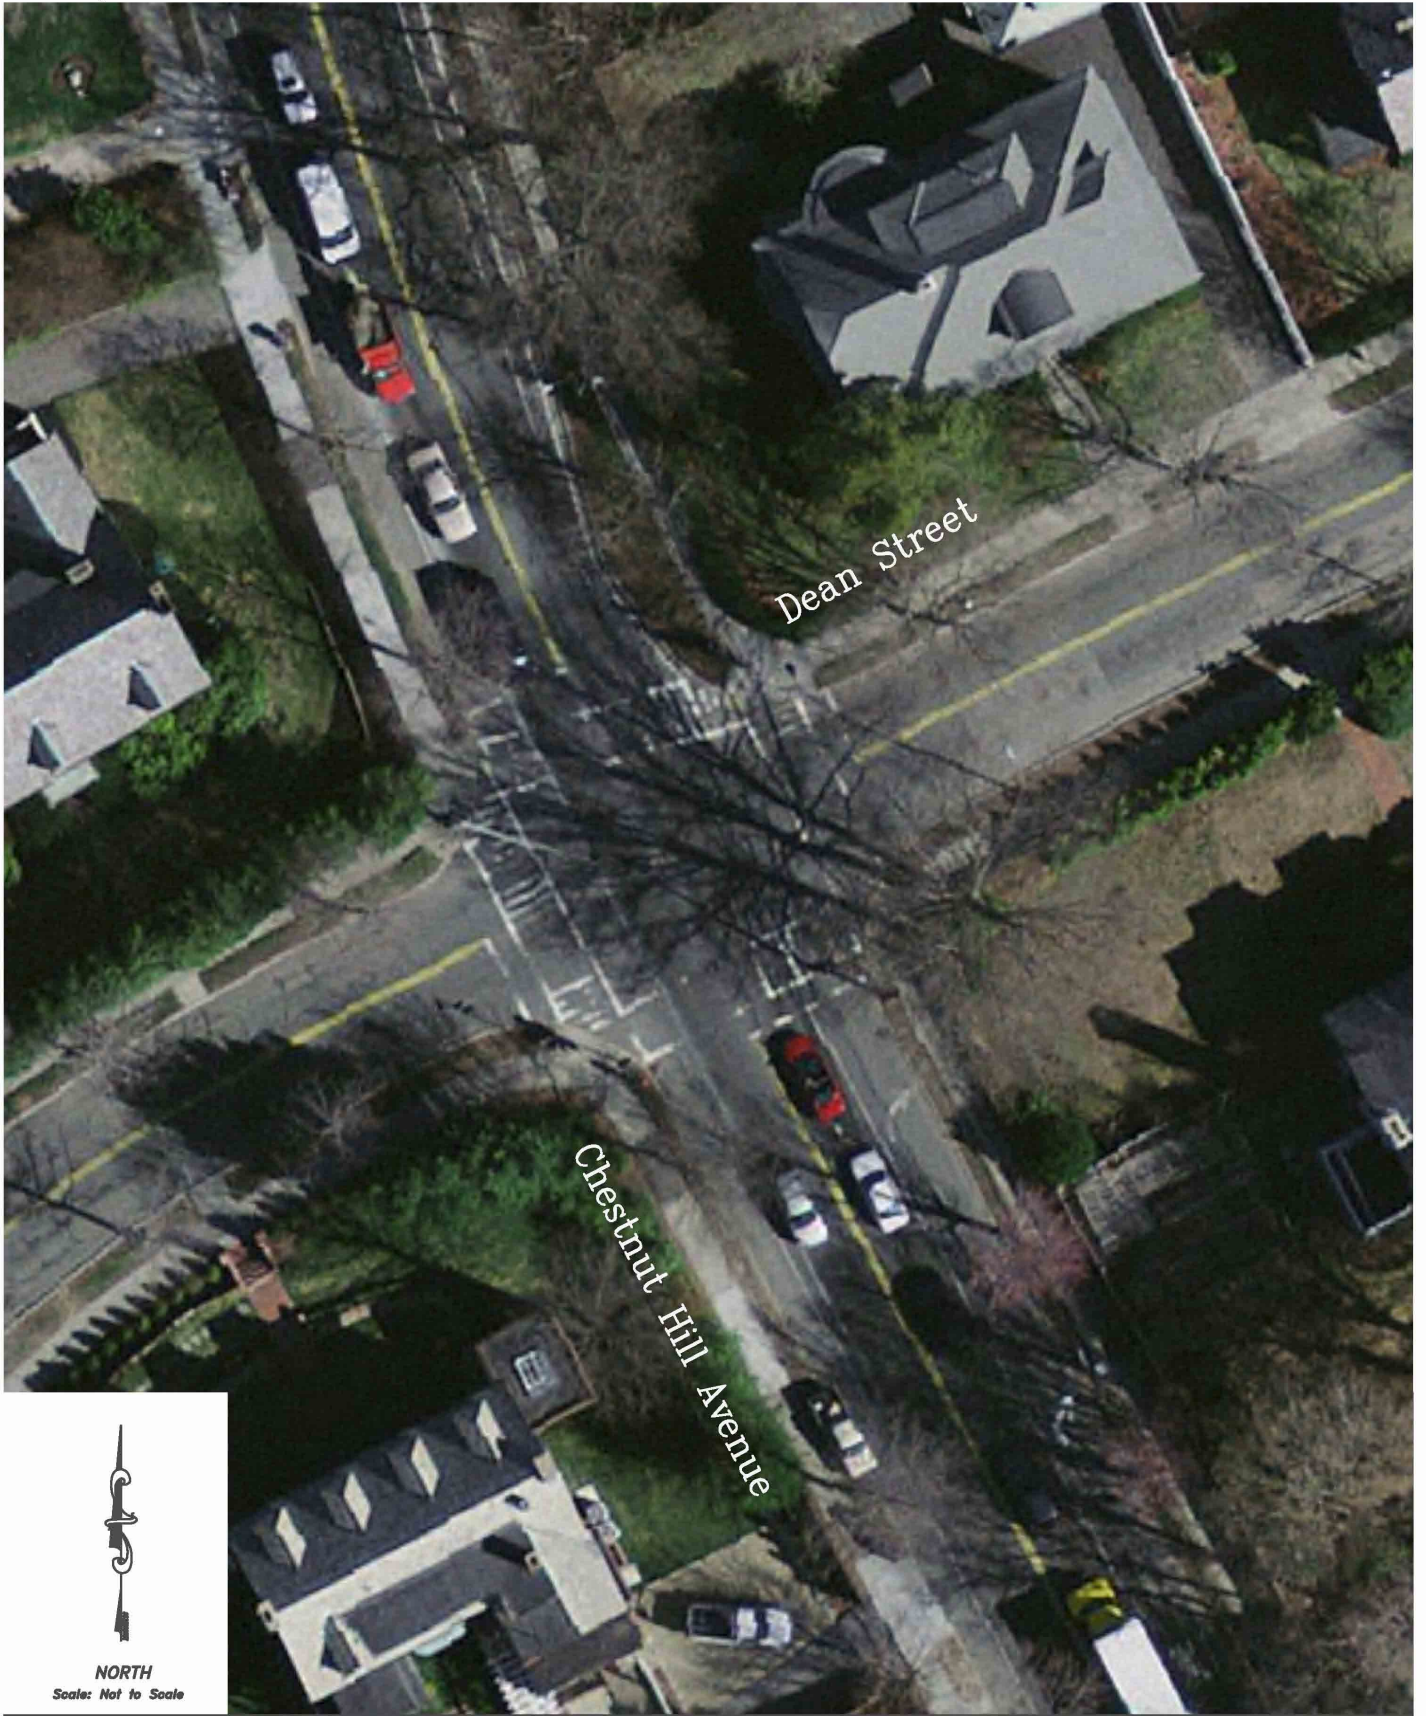
Figure 1

Study Location

The purpose of this study is to determine if the right turn restriction on the Chestnut hill Street southbound approach and the Dean Street westbound approach at the Chestnut Street at Dead Street intersection is warranted. The study location can be seen in **Figure 1**. Recommendations will be based on the guidelines found in the latest version of the Manual of Uniform Traffic Control Devices (MUTCD). The MUTCD suggests the following factors should be considered for the implementation of a NO TURN ON RED restriction:
