Town of Brookline

Walnut Street
Traffic Calming Evaluation

October 2003

BETA Group, Inc.
Engineers • Scientists • Planners
315 Norwood Park South, Norwood, MA 02062 781.255.1982
email: beta@beta-inc.com

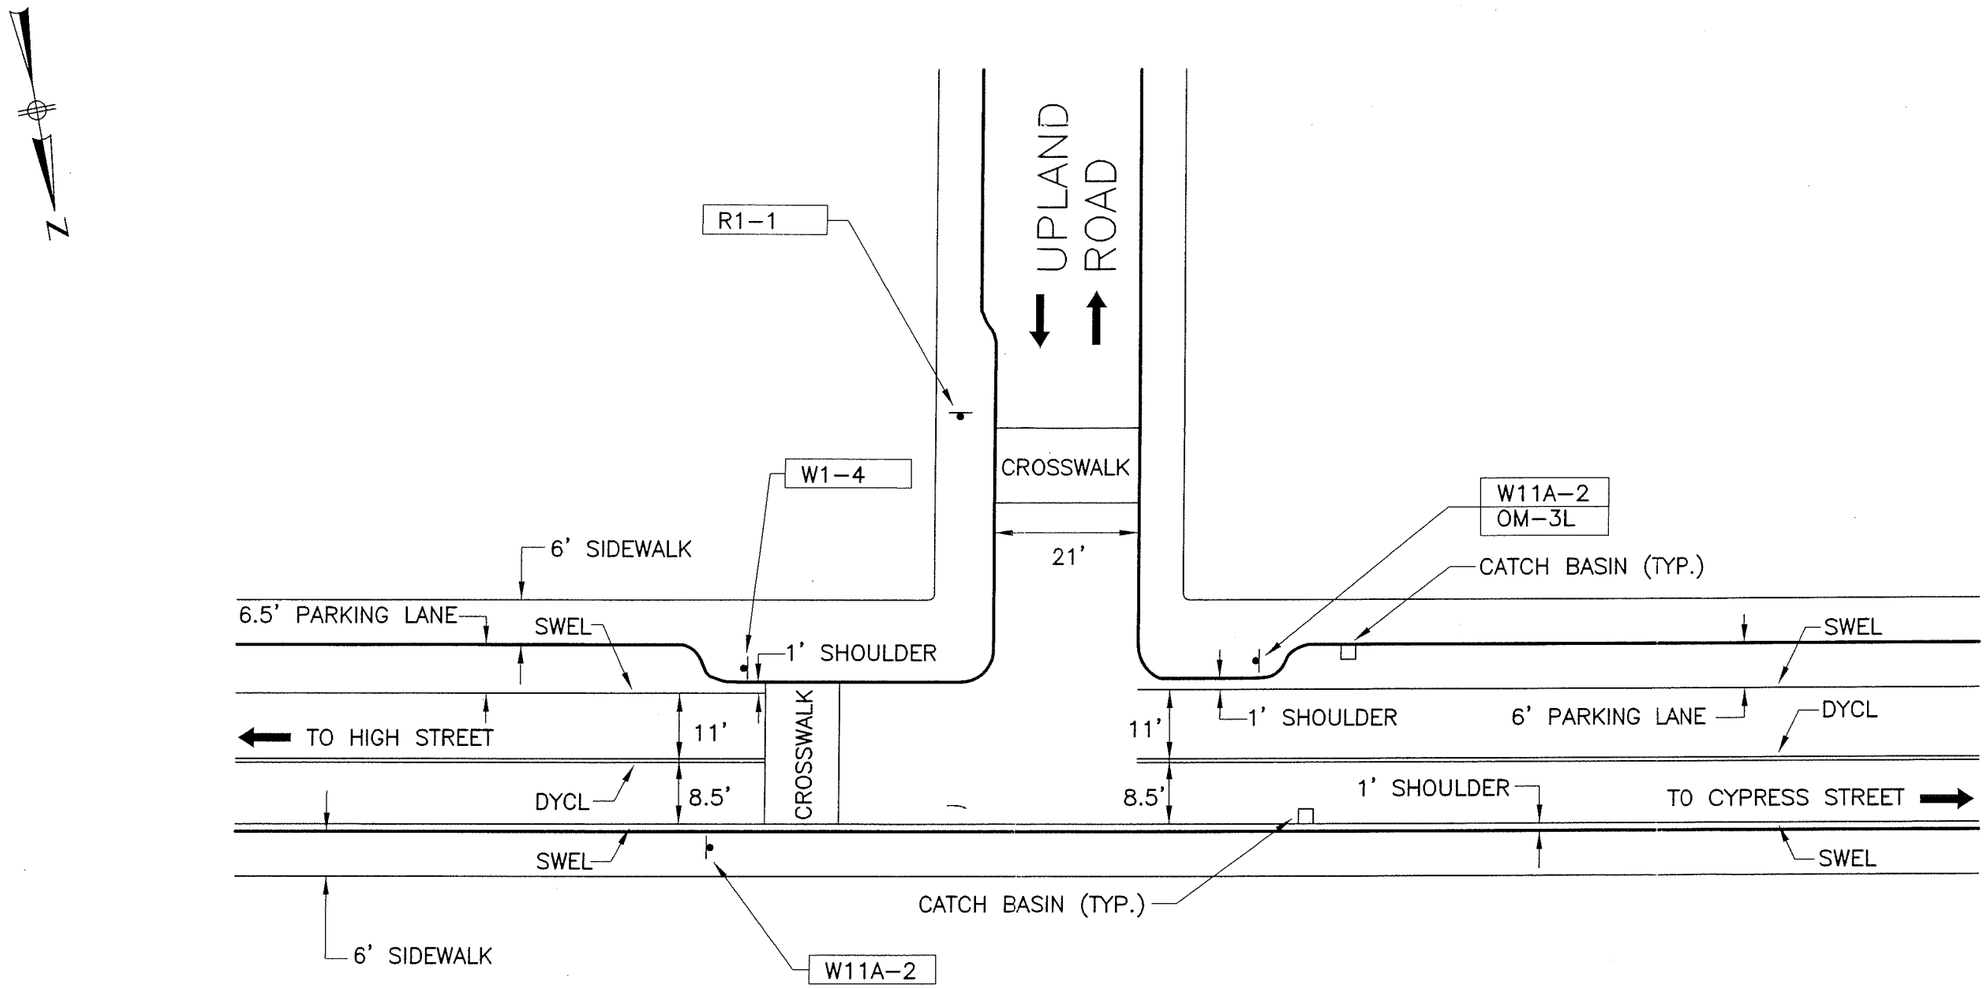
Figure No. 2
Neckdown @ Upland Road

The Upland Road neckdowns narrow the Walnut Street travel lane to 8.5 feet and 11 feet for the westbound and eastbound travel directions, respectively. A one-foot shoulder is also provided for both travel directions. The westbound 8.5-foot travel lane does not meet the Massachusetts Highway Design Standard and AASHTO minimum roadway width (10-foot) for a collector street. The sub-standard lane width (8.5 feet) is unsafe from an operational standpoint.

The intersection turning radius at these two intersections are tide specifically the Upland Street intersection. The neckdowns extended the curb at these intersections and thereby reducing the intersection turning radius.

The physical aspect of the neckdowns appears to be well constructed with no signs of deteriorating material or loose curb joints. However, based on our field investigation, the overall design of the neckdown area which reduces the travel lane widths to 8.5 feet coupled with a 6.5-foot on-street parking lane does not conform to the Massachusetts Highway Design Manual and AASHTO standards. The narrow travel and parking lanes create safety problems and impede traffic flow along Walnut Street.

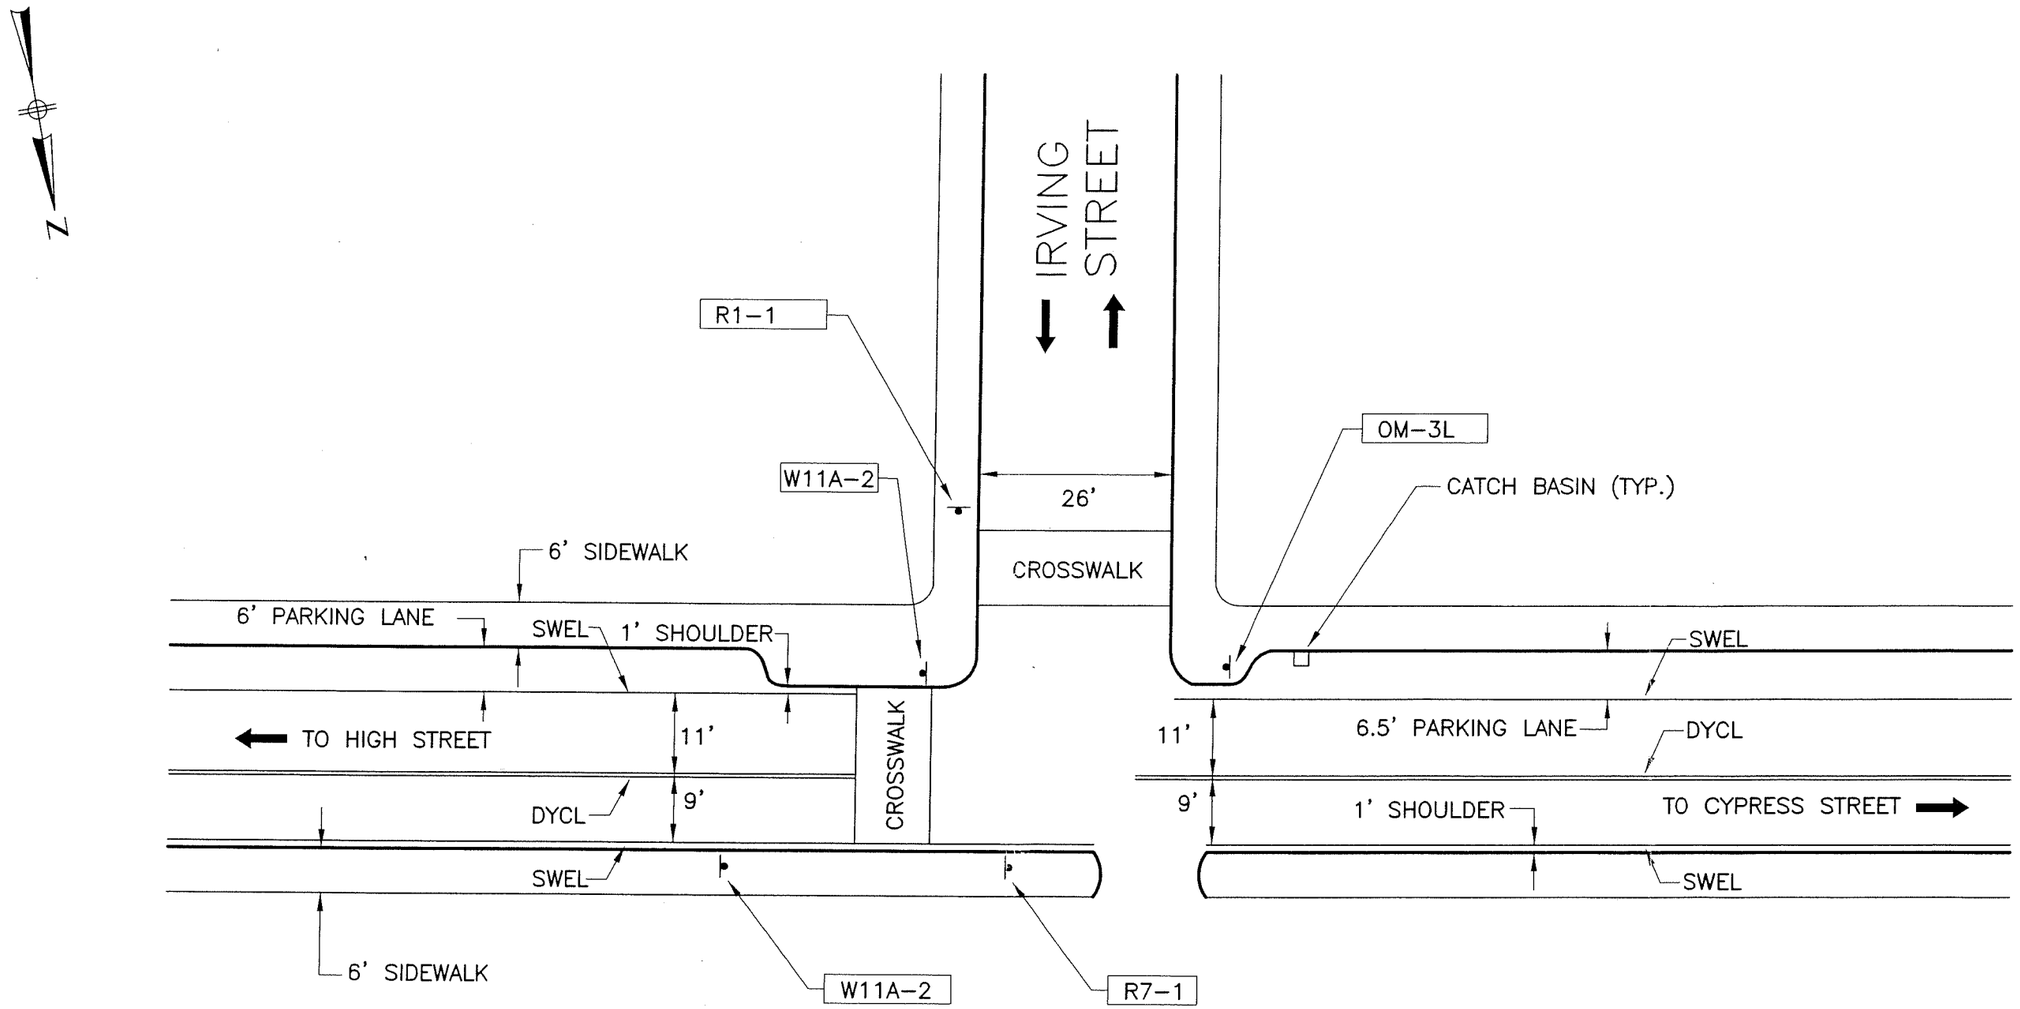
Figure No. 3
Neckdown @ Irving Road

The neckdown at the southeast corner of the Irving Street intersection, as shown in Figure 3, is approximately five feet wide and thirty-one feet long while the southwest corner is approximately fourteen feet long and 4.5 feet wide. The neckdowns narrow the Walnut Street travel lane to approximately 9 feet and 11 feet for the westbound and eastbound travel directions, respectively. A one-foot shoulder is provided for westbound travel direction. The westbound 9-foot travel lane does not meet the Massachusetts Highway Design Standard and AASHTO minimum roadway width (10-foot) for a collector street. The sub-standard 9-foot travel lane is unsafe from an operational standpoint.

The pavement marking at both the intersections consist of the standard double yellow center line, single white edge line, parking lane line and crosswalk marking. The on-street parking lanes are provided along the southern side of Walnut Street in the vicinity of Upland Road and Irving Street. The 6.5-foot width on-street parking lane does not meet the 7-foot minimum requirement outlined in the Massachusetts Design Manual and AASHTO for collector streets. The narrow parking lane creates safety problems and will impede traffic flow along Walnut Street. At the Irving Street approach, vehicles are parked too close to Irving Street at the southwest corner of

the intersection on Walnut Street, thereby obstructing the sight distance for traffic entering onto Walnut Street from Irving Street.

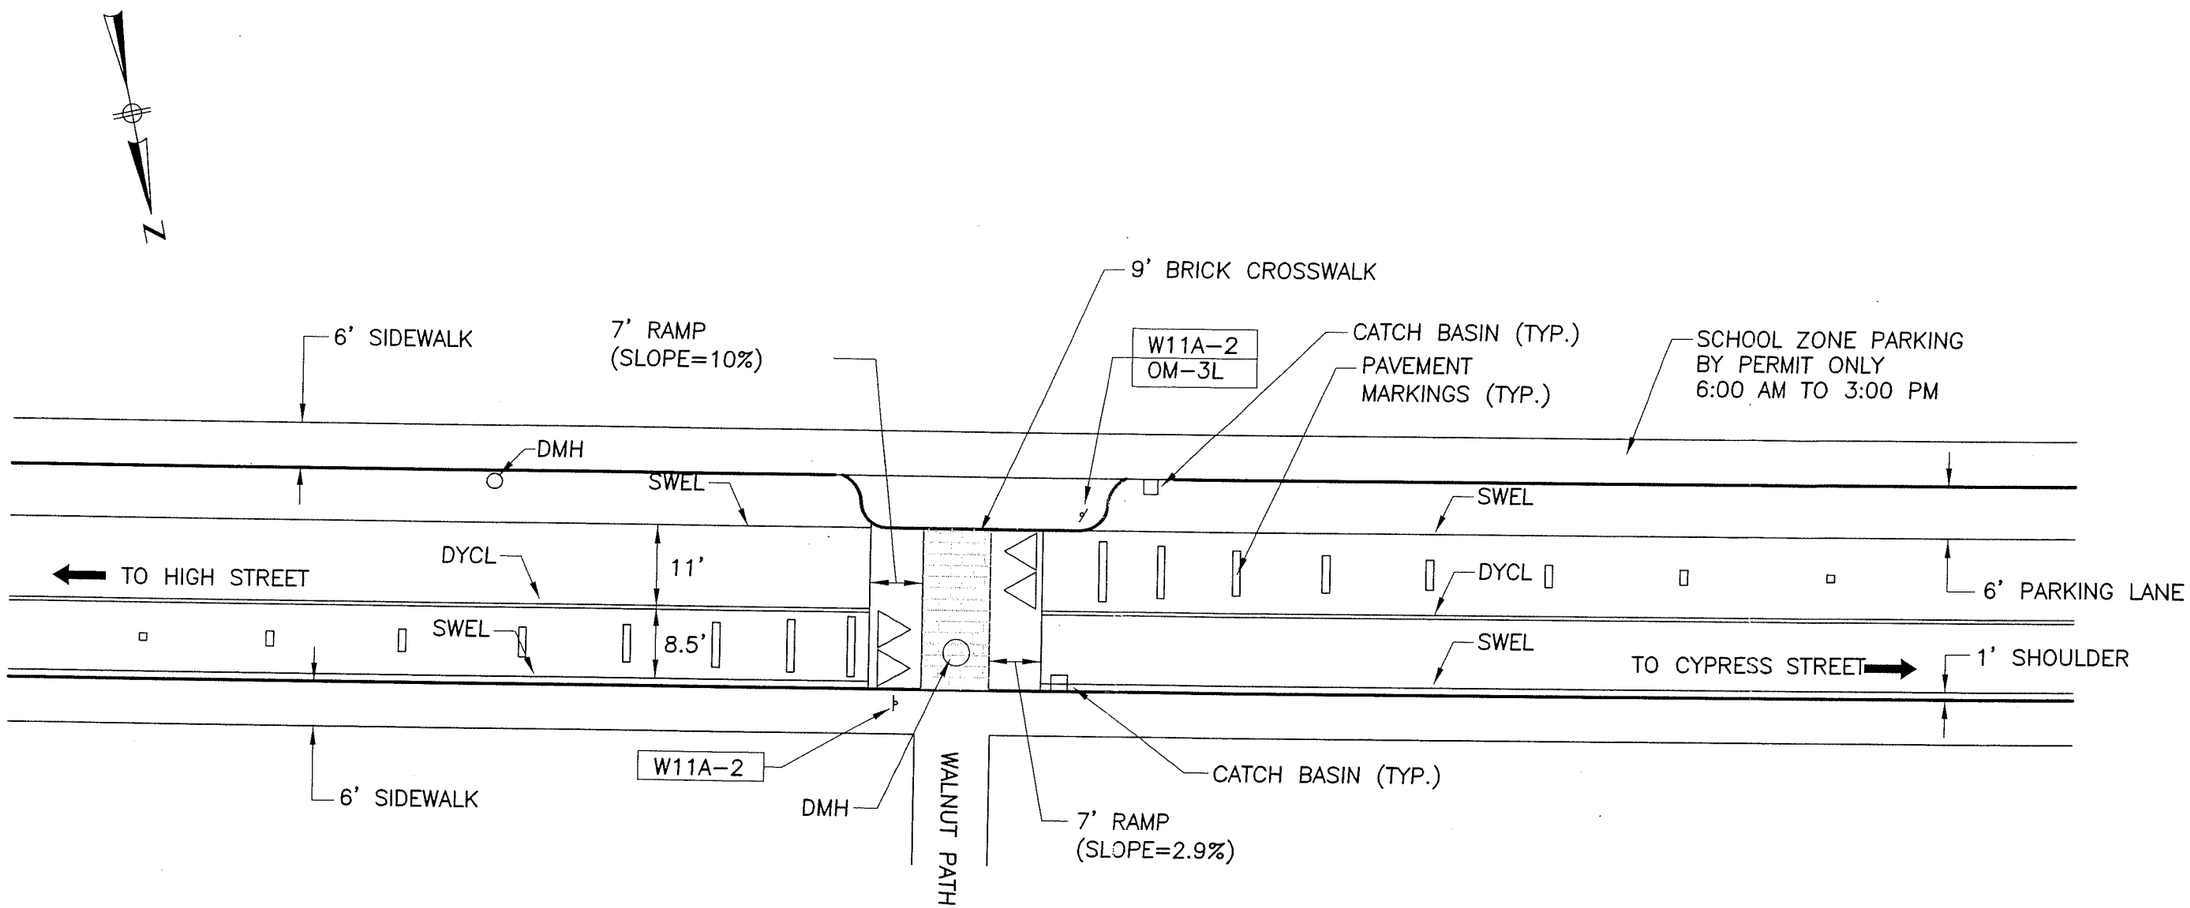
Figure No. 4
Raised Crosswalk
@ Walnut Path

The crosswalk is approximately nine feet wide with seven-foot ramps. The height of the raised crosswalk is approximately six inches. Field measurements utilizing the Smart Level revealed that the ramp slopes are 10.0% for the east side and 2.9% for the west side.

The device shows no signs of deteriorating material such as loose curbs or brick paver joints. The overall design of the device meets the minimum design criteria for a raised crosswalk as outlined in the ITE Traffic Calming State of the Practice with the exception of the ramp slope and the curb extension area which reduces the travel lane width to 8.5 feet. If the goal is to reduce vehicular speed to 20 mph at the raised crosswalk, the 10% and 2.9% slopes do not meet the ITE design standard, which calls for 8% ramp slopes.

The 10% ramp slope exceeded the industry standard for raised crosswalk of 8% ramp slope for a 20 mph travel speed. The 10% slope will create safety problem for vehicle crossing the raised crosswalk and vehicle may air borne and bottom out as they depart from the device. The 2.9% slope will allow vehicles to cross the raised crosswalk at speeds greater than the 20 mph posted advisory speed. In addition, the transition between the existing roadway and the crosswalk ramps

is abrupt due to poor vertical transition from the roadway to the crosswalk ramps. This poor vertical transition and the substandard slopes accounts for the pavement injury that exists in the area departing the raised crosswalk from both the travel directions.

Pavement damage exists on the departing side of the raised crosswalk in both travel directions. The scraped pavement indicates that vehicles are traveling at high speeds crossing the raised crosswalk and bottoming out as they depart from the device. The speeding at this raised crosswalk is a result of the steep ramp slope (10%) and the wide spacing between the traffic calming devices, which provides vehicles an opportunity to increase speed between the devices.

- Restrip travel lane and parking lane widths to provide a 7 foot parking lane and 10 foot travel lane to conform with AASHTO and MassHighway design standards for travel lane and parking widths for collector roads.
- Improve raised crosswalk ramp slopes to meet industry standards for a 20 MPH design speed, which calls for an 8% slope.
- Install catch basins east of the raised crosswalk to prevent ponding of water at the ramp at the eastern edge of the crosswalk.
- Replace the existing pedestrian crossing sign (W11A-2) with "Raised Crossing" sign.
- Removed advance signage for raised crosswalk. Also, see signage improvements section.

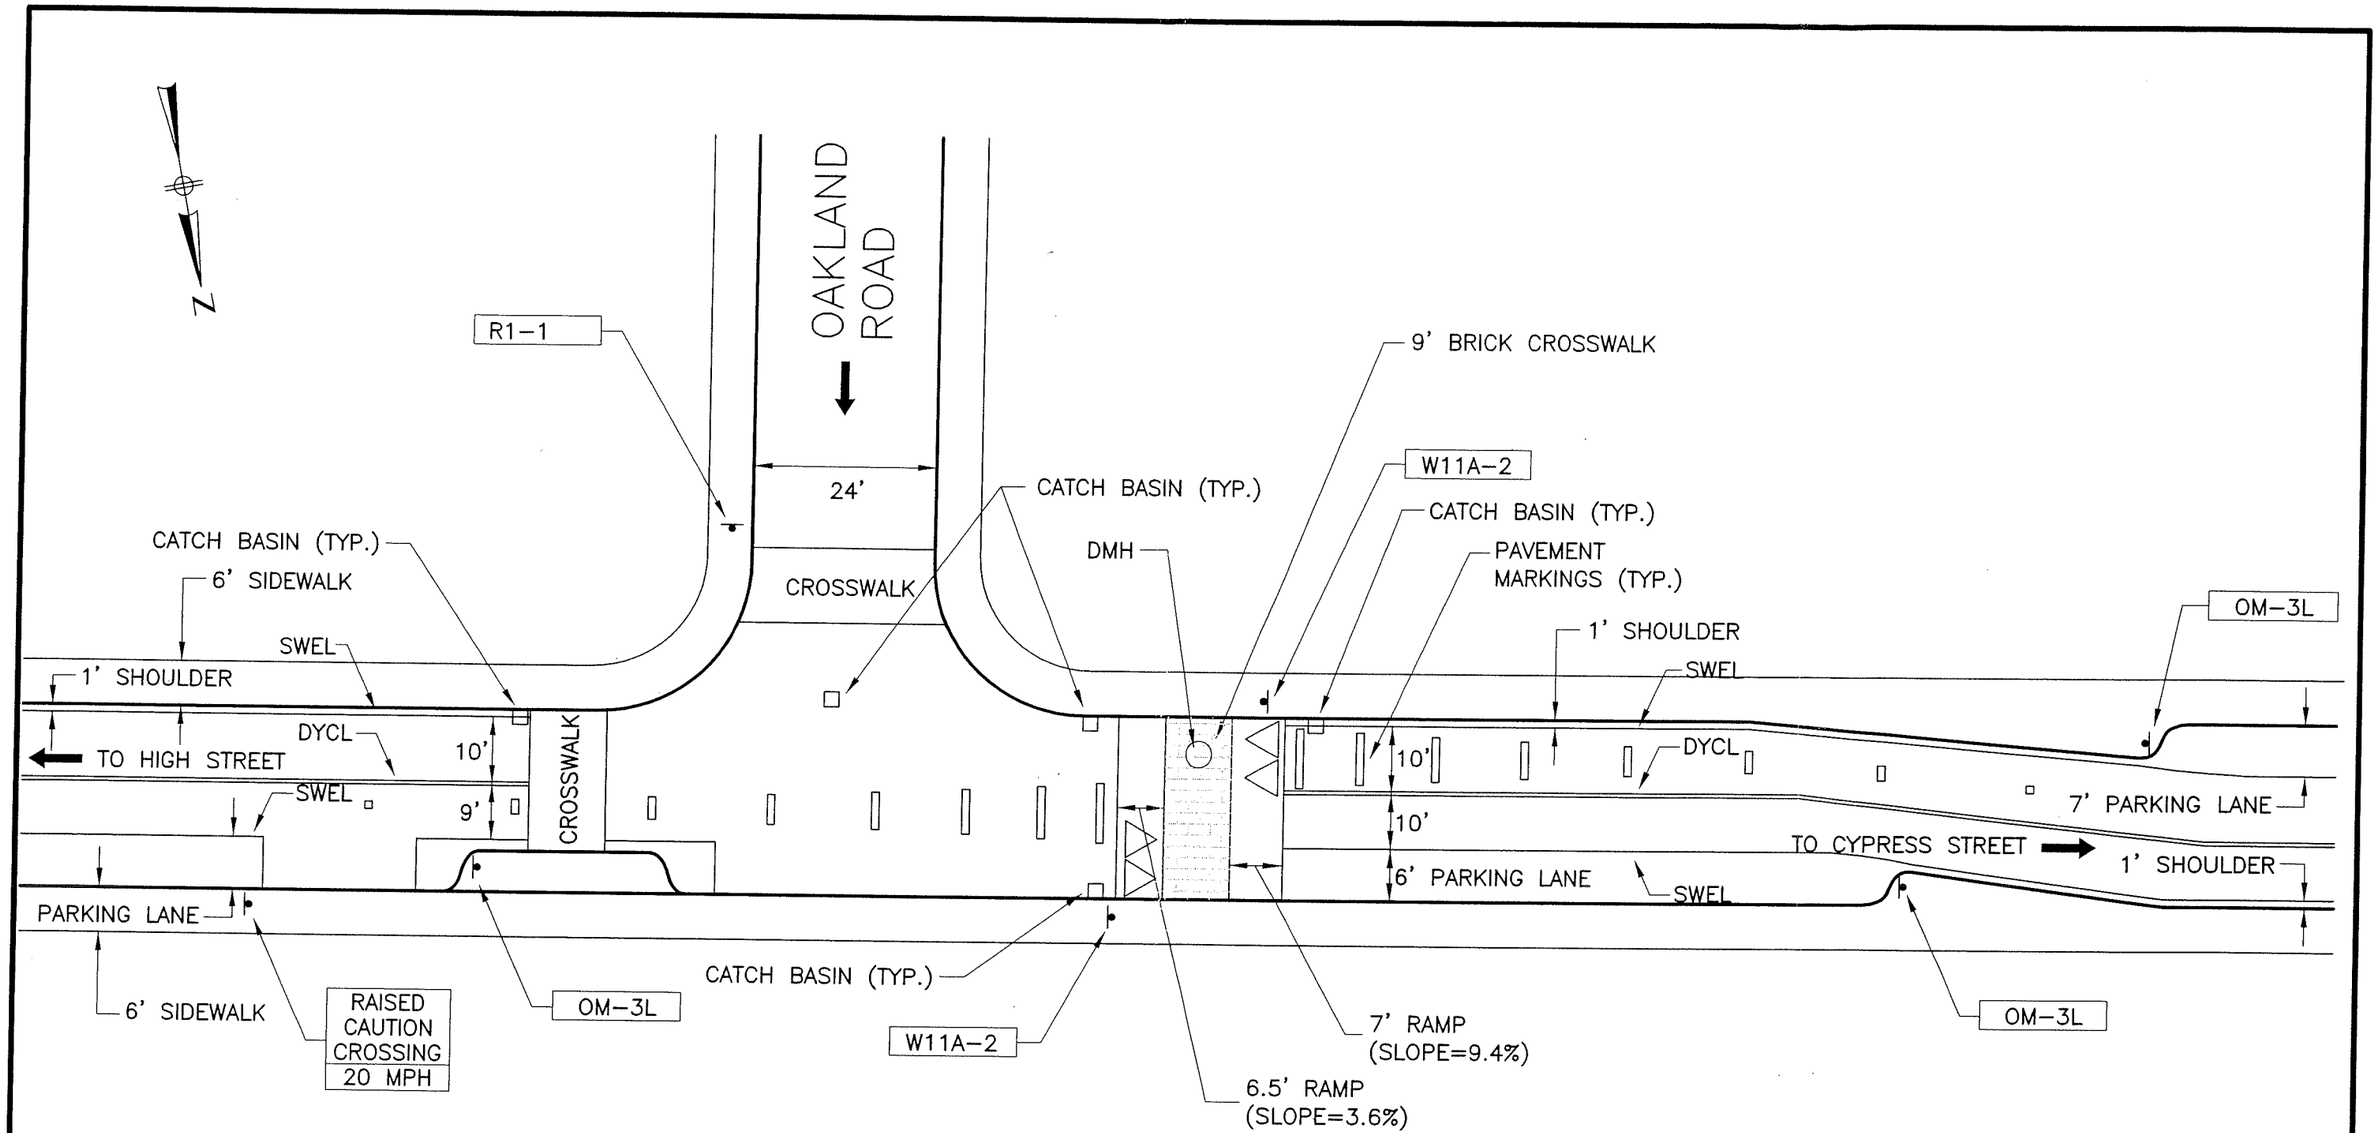
Figure No. 5
Raised Crosswalk and Chicane @ Oakland Road

is approximately nine feet wide with 7-foot ramps. The height of the raised crosswalk is approximately five inches. Field measurements utilizing the Smart Level revealed that the ramp slopes are 3.6% for the east side and 9.4% for the west side.

The neckdown curb extension at the northeast corner of the intersection is approximately thirty-two feet long. It extends approximately 5.5 feet from the existing sidewalk edge into the roadway. There are catch basins at the northeast, southeast and southwest corners of the raised crosswalk, one in the middle of the intersection and on at the southeast corner of the intersection to drain roadway runoff. The materials used for the raised crosswalk consist of brick pavers on the crosswalk area and cement concrete ramps. The neckdown is constructed of granite curb with cement concrete for the curb extension area. The neckdown curb extension narrows the Walnut Street travel lane to 9 feet and 10 feet for the westbound and eastbound travel directions, respectively. The westbound 9-foot travel lane does not meet the Massachusetts Highway Design Manual and AASHTO design standards for a collector street. A one-foot shoulder is provided on the north side of the street. The sub-standard lane width (9- foot) is unsafe from an operational standpoint. A one-foot shoulder is provided on the north side of Walnut Street. The 6.0-foot width on-street parking lane does not meet the 7-foot minimum requirement outlined in the Massachusetts Design Manual and AASHTO design standard for collector streets. The narrow parking lanes create safety problems and impede traffic flow along Walnut Street.

The west side of the ramp slope (9.4%) exceeds the industry standard for raised crosswalk which

is 8% for a 20 mph travel speed. However, the east side of the slope (3.6%) is less than 8%, which allows vehicles to cross the raised crosswalk at speeds greater than the 20 mph posted advisory speed. The substandard slope accounts for the pavement injury that exists in the area departing the raised crosswalk from both the travel directions. The scraped pavement indicates that vehicles are traveling at high speeds exceeding the posted 20 mph advisory speed when crossing the raised crosswalk and bottoming out as they depart from the device. The speeding at the raised crosswalk is also due to the wide spacing between the two raised crosswalks.

The overall device is well constructed with no signs of deteriorating material or loose curb or brick paver joints. Similarly, the overall design of the device meets the minimum design criteria for a raised crosswalk as outlined in the ITE Traffic Calming State of the Practice with the exception of the raised crosswalk ramp slope and the neckdown, which reduce the travel lane width to 9 feet.

- Restrip travel lane and parking lane widths to provide a 7 foot parking lane and 10 foot travel lane to conform with AASHTO and MassHighway design standards for travel lane and parking widths for collector roads.
- Reconstruct raised crosswalk ramp slopes to meet industry standards for a 20 MPH design speed, which calls for an 8% slope.
- Replace the existing pedestrian crossing sign (W11A-2) with "Raised Crossing" sign.
- Removed advance signage for raised crosswalk. Also, see signage improvements section.
